Manhole Inspection Summary

Manhole # S59AA_002MH

Insp Date: **3/21/08 9:03 AM**

Location Address: **East Monument Street** Cross Street: **Pulaski Highway**

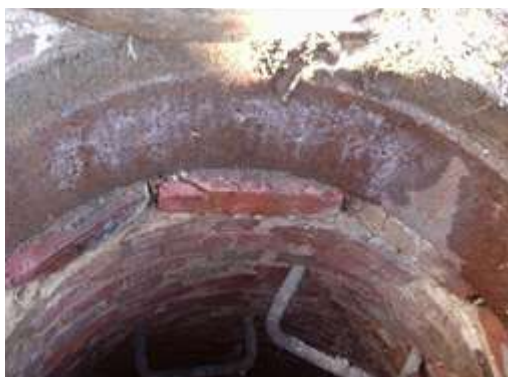
Defect 1

Chimney / Frame Adjustment ☒ Exists Material: **Brick** ☐ Parged Height: **9** (in.)
Condition: ☐ Sound ☐ Cracked ☐ Root Intrusion ☒ **Loose Brick** ☐ Deteriorated
Infiltration: ☐ None ☒ **Joint** ☐ Cracks ☒ **Mortar** ☐ Roots ☐ Wall

Loose brick

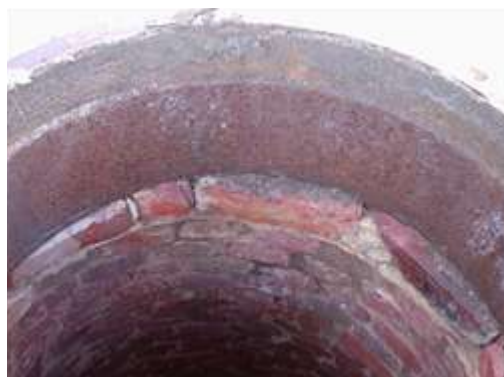
Defect 2

Frame Offset: **1** (in.) Condition: ☐ Sound ☐ Cracked ☒ **Leaks**

Frame leaks

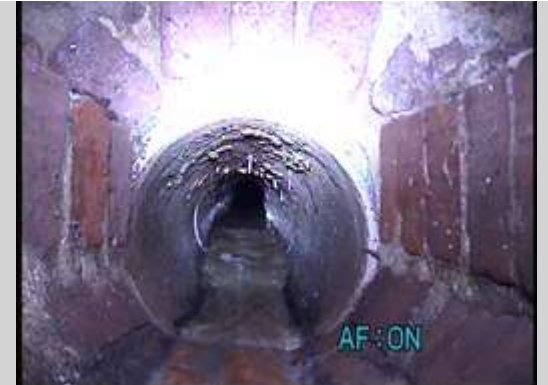
12 O'Clock Outflow

8 in. Circular Gravity Sewer
Pipe Out @ 12 O'Clock

Pipe Height: **8.4** (in.) Rod and Bar (Angled)
Pipe Material: **Clay** ☐ Pipe Lined
Invert Depth: **8.90** (ft.) Flow Characteristics: **Fast**
Deposits: ☒ None ☐ Mud ☐ Sludge ☐ Debris ☐ Grease
Silt Depth: (in.) Deposits Extent:
Infiltration: **None** Pipe Seal Cond: **Sound**

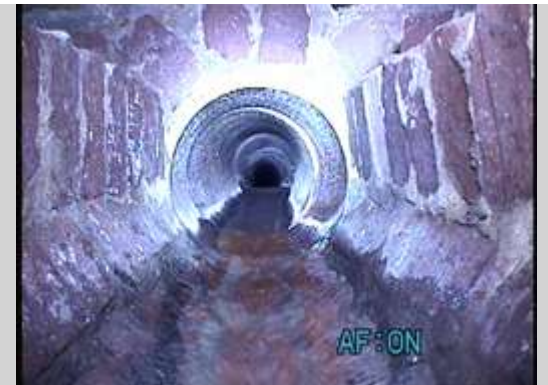
6 O'Clock Inflow

8 in. Circular Gravity Sewer
Pipe In @ 6 O'Clock

Pipe Height: **8.4** (in.) Rod and Bar (Angled)
Pipe Material: **Clay** ☐ Pipe Lined
Invert Depth: **8.60** (ft.) Flow Characteristics: **Fast**
Deposits: ☒ None ☐ Mud ☐ Sludge ☐ Debris ☐ Grease
Silt Depth: (in.) Deposits Extent:
Infiltration: **None** Pipe Seal Cond: **Sound**

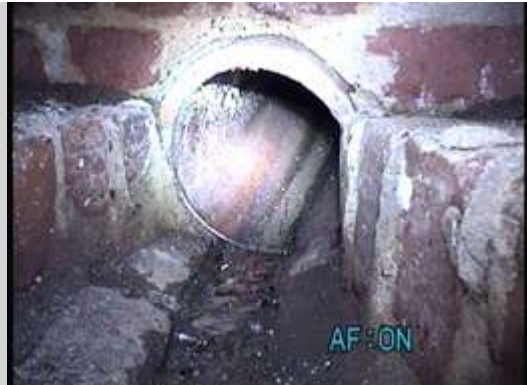
9 O'Clock Inflow

8 in. Circular Gravity Sewer

Pipe In @ 9 O'Clock

Pipe Height: **8.4** (in.) Rod and Bar (Angled)

Invert Depth: **8.40** (ft.) Flow Characteristics: **Slow**
